**OLD GRIST MILL POND DAM
MA 00668**

PHASE I INSPECTION REPORT NATIONAL DAM INSPECTION PROGRAM

OCTOBER 1978

Identification No.: MA00668

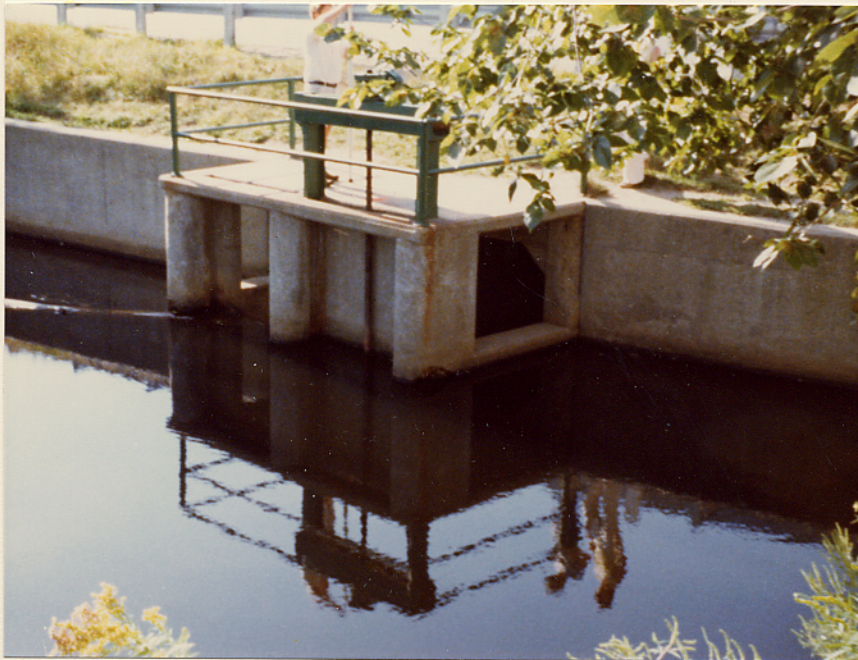
Severe erosion and spalling of the concrete has occurred along the water line of the outlet structure. The upstream edges of the sidewalls and of the pier separating the bays all

show signs of spalling at the water line and are in poor condition. Rusting was also noted along the keyway for the flashboards, and it was observed that the joints between the outlet structure and the upstream headwall are open and unfilled. The downstream face of the center pier and the headwall above the slide gate is eroded and pieces of concrete are missing. Slight seepage was observed flowing from the top of the slide gate.

**NO. 1 VIEW OF SPILLWAY
AND OUTLET STRUCTURE**

- a. Operating and Maintenance Procedures. The dam and appurtenant structures are not adequately maintained. It is recommended that the Owner accomplish the following:
 - (1) repair the concrete on the upstream and downstream faces of the outlet structure
 - (2) fill in joints where the structure meets the upstream wall of the dam; repair leakage at the top of the outlet gate

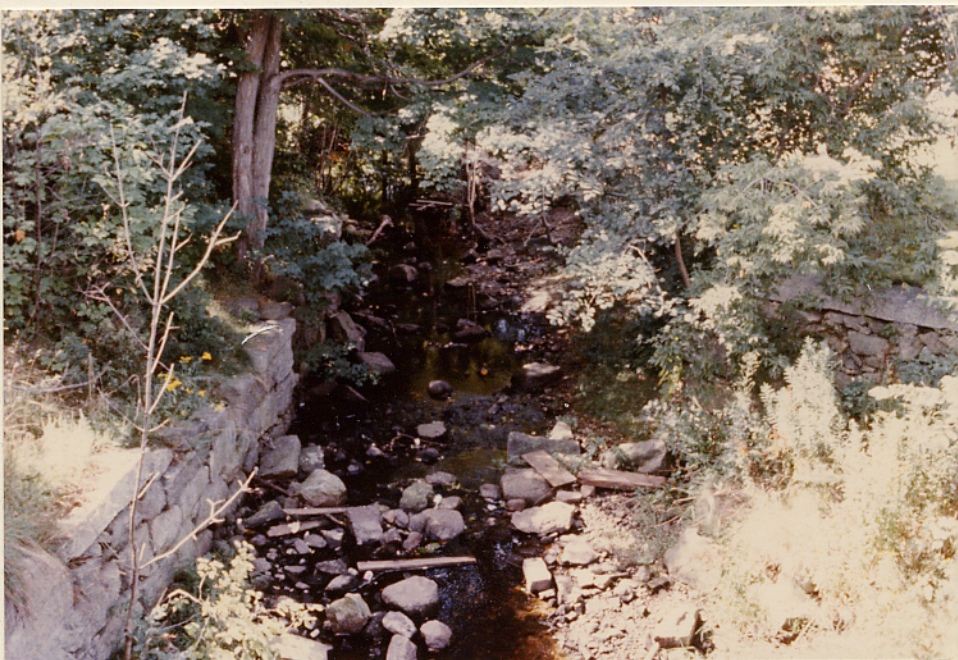
The stream bed below the box culvert is thickly overgrown and in poor condition. The stonework in the sidewalls is deteriorating, and blocks of rock are overhanging and falling into the channel. Other rocks and riprap washed downstream have accumulated in the floor to a level about 2 feet above the invert of the box culvert. Numerous trees and brush are growing along the sides and bottom of the stream bed, especially on the east side slope where 24-inch and 30-inch diameter trees are growing.

**NO. 2 VIEW OF STREAM BED
BELOW DAM**

- (5) repair deteriorating stonework in the walls of the downstream channel
- (6) monitor the seepage at the toe of the dam west of the box culvert
- (7) clear the tree at the toe of the dam east of the box culvert

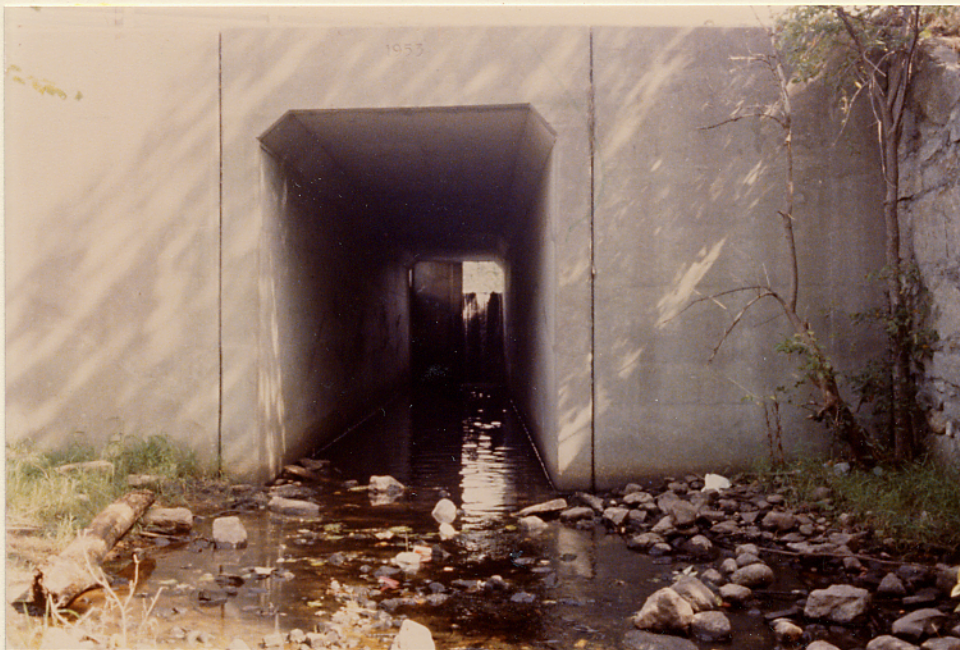
The concrete of the box culvert is generally in good condition. There is some slight erosion and staining along the water line. Some slight seepage is also occurring along two construction joints, and diagonal efflorescence was observed about midway in the culvert. The concrete walls contain small patches where construction ties have been cut off. Rock debris has accumulated on the floor of the culvert.

**NO. 3 VIEW OF DOWNSTREAM FACE OF DAM AND
BOX CULVERT**

- (8) repair erosion of the upstream and downstream slopes of the dam near the west abutment
- (9) repair minor efflorescence and seepage at construction joints in the walls of the box culvert

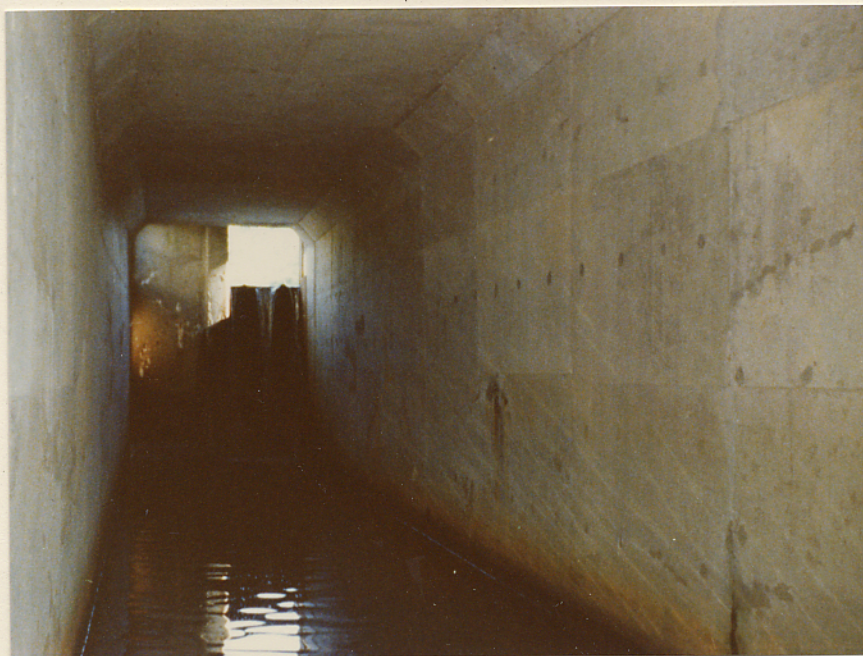
**NO. 4 VIEW OF WALLS OF BOX CULVERT
AND DOWNSTREAM SIDE
OF SPILLWAY/OUTLET STRUCTURE**

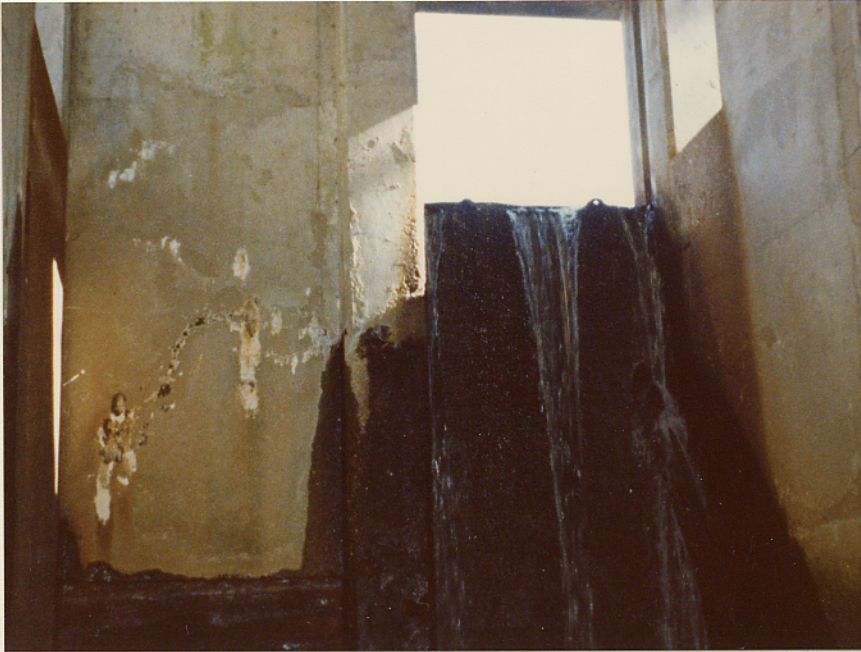
**NO. 5 CLOSE-UP OF DOWNSTREAM SIDE OF
SPILLWAY ON RIGHT AND CONCRETE
HEADWALL ABOVE OUTLET ON LEFT**

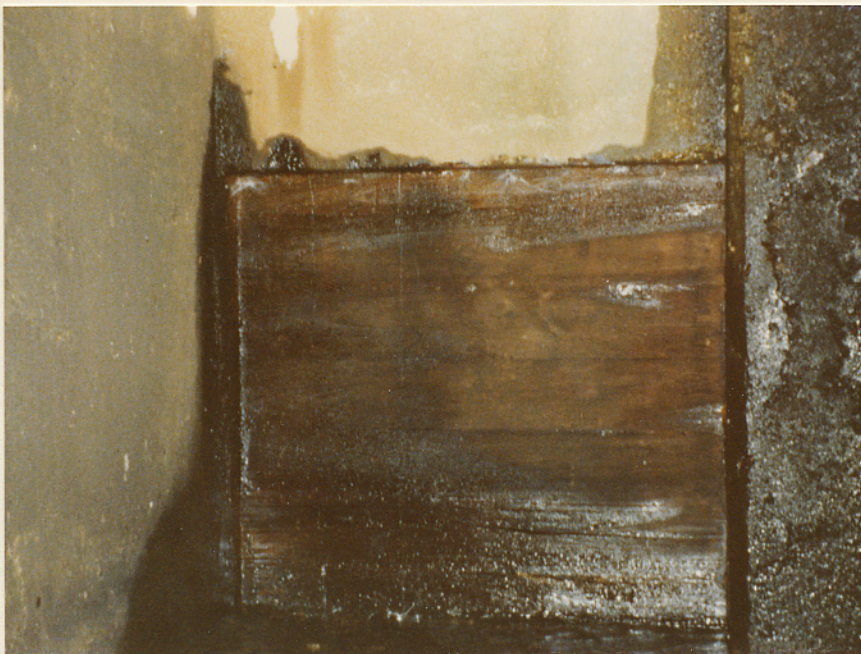
**NO. 6 CLOSE-UP OF WOODEN SLIDE
GATE FOR OUTLET CONTROL**
